[Docket No. FAA-2014-0034; Directorate Identifier 2013-SW-006-AD]

Airworthiness Directives; Eurocopter Deutschland GmbH Helicopters

ACTION: Notice of proposed rulemaking (NPRM).

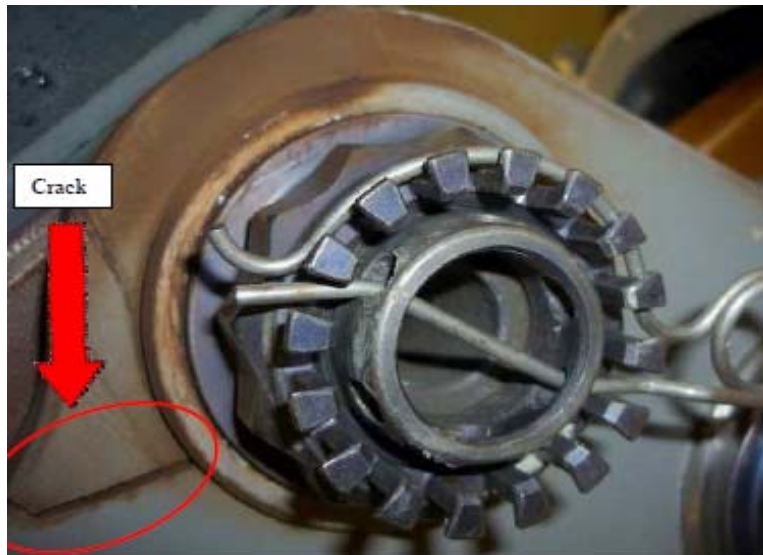
Figure 1 to Paragraph (f)(1)

(1) Before further flight, and thereafter at intervals not to exceed 6 hours time-in-service (TIS), check the MRH shaft lower flange and the visible area of the MRH shaft upper flange for a crack. Figures 1 and 2 to Paragraph (f)(1) of this AD are examples of cracks that have been discovered in the MRH shaft lower flange. The actions required by this paragraph may be performed by the owner/operator (pilot) holding at least a private pilot certificate, and must be entered into the aircraft records showing compliance with this AD in accordance with 14 CFR §§ 43.9 (a)(1)-(4) and 14 CFR § 91.417(a)(2)(v). The record must be maintained as required by 14 CFR §§ 91.417, 121.380, or 135.439.

(3) If there is a crack in the upper or lower MRH shaft flange, before further flight, replace that MRH shaft with an airworthy MRH shaft. Replacing the MRH shaft with an MRH shaft having a P/N listed in the applicability of this AD does not constitute terminating action for the requirements of this AD.
